# Manhole Inspection Summary

Manhole # S35M\_\_005MH

**Inspection** ☐ Is Incomplete Rating: **5) Immediate Attention Required**

**Location** Address: **601 light st**

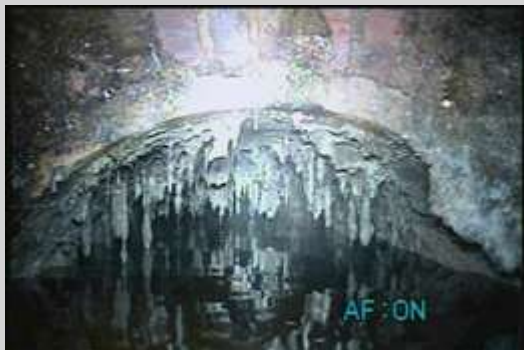
12 O'Clock Outflow

30 in. Circular Gravity Sewer  
Pipe Out @ 12 O'Clock

Pipe Material: **Clay** ☐ Pipe Lined

Invert Depth: **18.92** (ft.) Flow Characteristics: **Fast**

Infiltration: **None** Pipe Seal Cond: **Unknown**

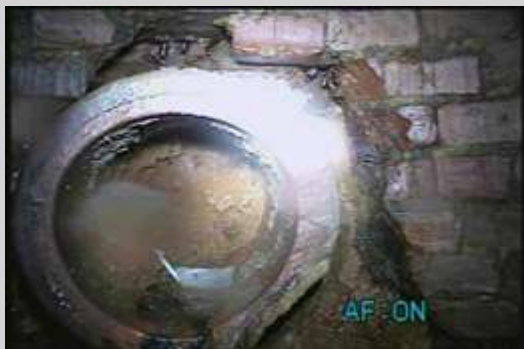
5 O'Clock Inflow

8 in. Circular Gravity Sewer  
Pipe In @ 5 O'Clock

Pipe Material: **Clay** ☐ Pipe Lined

Invert Depth: **12.54** (ft.) Flow Characteristics: **Fast**

Infiltration: **None** Pipe Seal Cond: **Unknown**

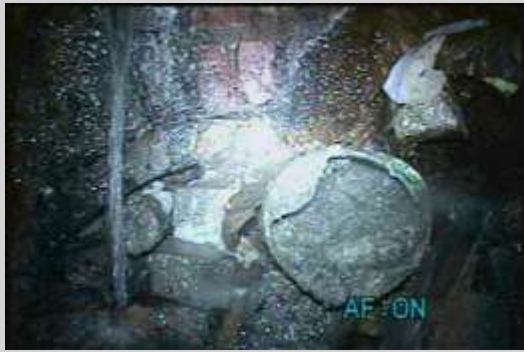
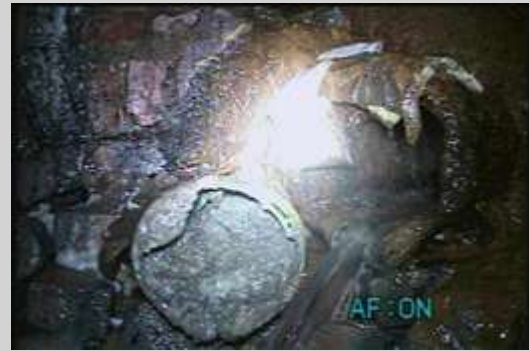
6 O'Clock Inflow

8 in. Circular Gravity Sewer

Drop: **Outside** **Direct**

Drop Condition: **Open**

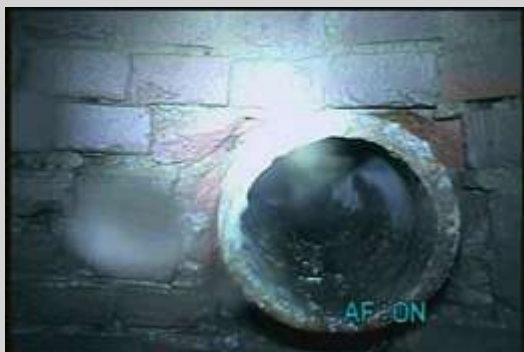
Drop In @ 7 OClock

6 in. Circular Gravity Sewer

7 O'Clock Inflow

Infiltration: **None** Pipe Seal Cond: **Unknown**
